ENGINEERING CASE LIBRARY

Improving Odometer Reliability
at
Stewart-Warner Corporation (A)

Improving Odometer Reliability
at
Stewart-Warner Corporation (B)

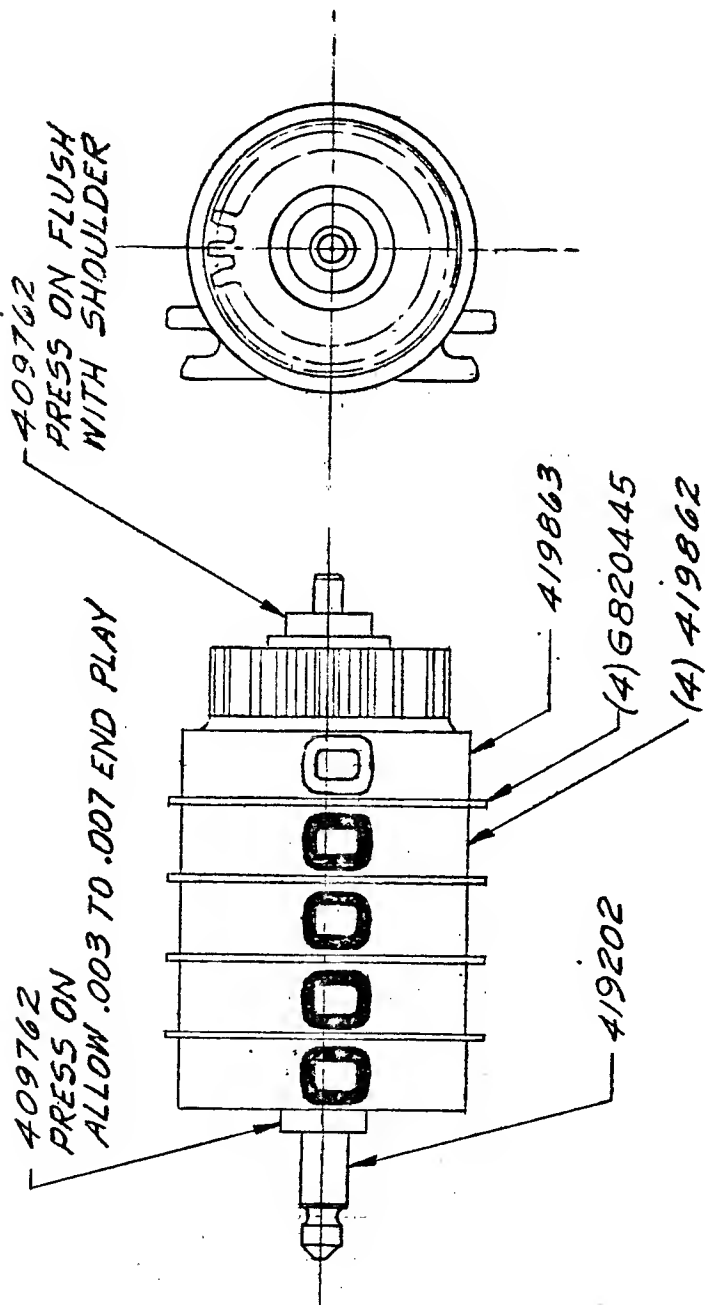
Exhibit A-2 ODOMETER ASSEMBLY DRAWING

"From all field reports of odometer failures," Mr. Johnson said, "one thing was getting very clear. In practically every case the proper contact between the brass pinion and the adjacent dial wheel was lost. We had specified a 0.003 to 0.007 inch end play for the whole odometer assembly (Refer to Exhibit A-2), and to secure this

we were using arbor presses with calibrated dial gauges in the assembly line. However, we were still getting too many failures." Finally the major problem was traced to the inconsistency of the pinion and carrier assembly in the production. Dimensional variations in the final assembly were found to be the reason for many failures. These variations were occurring during the assembly of the brass pinion with the two side brackets while automatically projection welding them together. Too much pressure, when holding them together on the plates for welding, was changing the overall thickness of the pinion and carrier assembly. This was resulting in the wrong spacing of each component of the odometer, causing slips or binding wheel actions. During assembly on the automatic welding machine, plates holding the two pinion brackets would also shift slightly from time to time, resulting in misalignment of the pinion bearing holes. This would cause tightness and pinion motion binding in the final assembly. 100% inspection was becoming too costly for the company to do it continuously. The dial wheels were not causing any trouble. They were made by an injection molding process on automatic machines using polystyrene as wheel material. "Besides," said Mr. Johnson, "we had \$100,000 invested in molds for these machines. To change them would be too costly. In the final analysis we had decided that our failures were caused by burrs still present in the assembled pinions, and by the inconsistency of the projection welding operation joining the two pinion brackets."

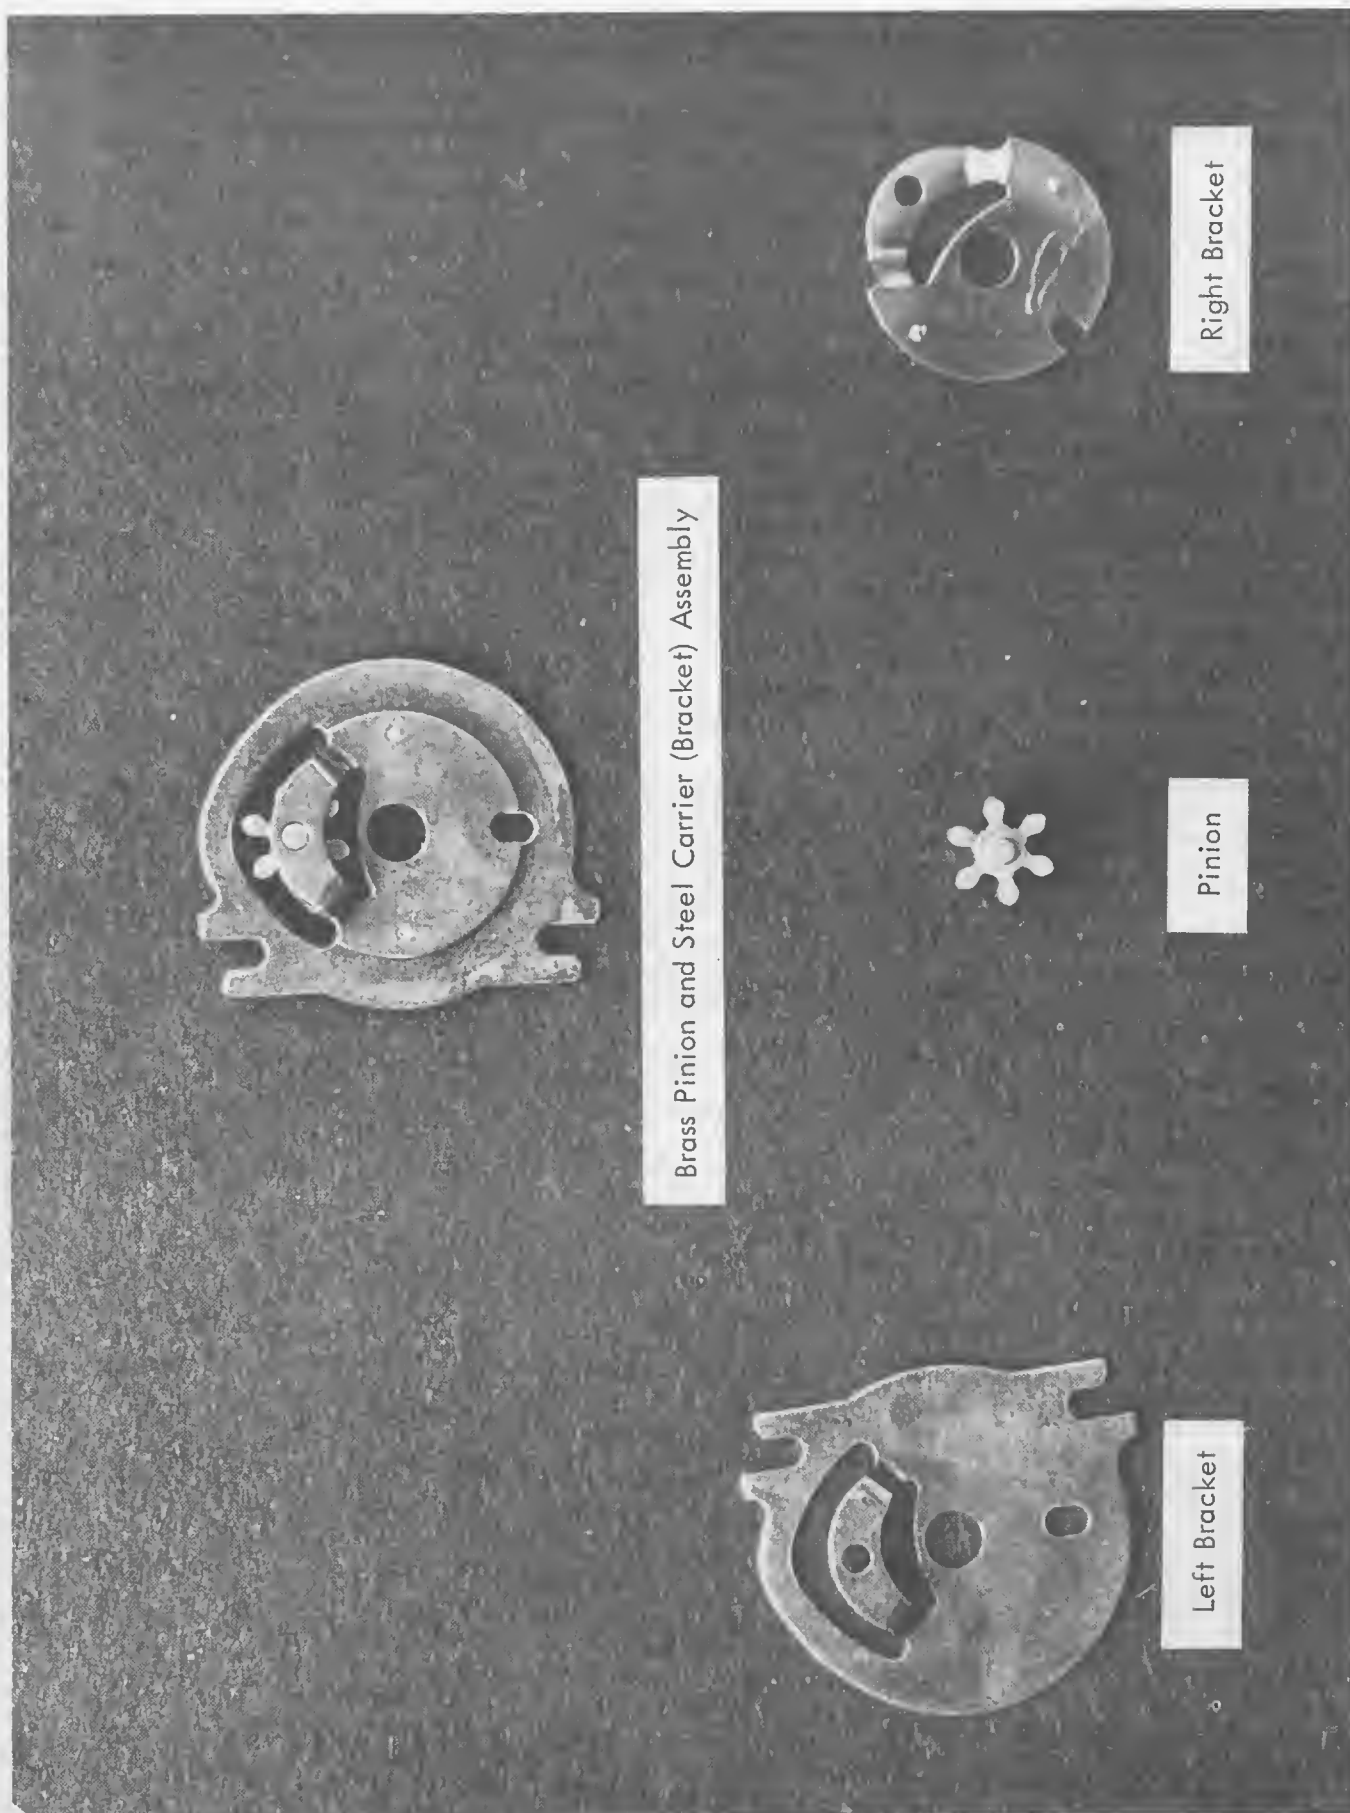
Exhibit A-10 PINION AND CARRIER ASSEMBLY

Mr. Powell was well acquainted with the shortcomings of the present design. The unremoved burrs on the brass pinion and the dimensional variations due to the welding operation were causing most of the difficulties. The company policy was such that after a design was completed in the design department, it was the production department's job to manufacture it properly. The brass pinions were made at S-W's own plant on an automatic continuous screw machine. Parts were made of extruded stock and teeth were cut on an indexing head. For burr removal the parts were placed in a tumbling barrel containing a special compound of Number 95 liquid Ventrol. This process was the best that the Production Department could suggest for the removal of the burrs; nevertheless, it was not producing satisfactory results.

- a. Variations in end play of (1) the between-segments pinion, and (2) the whole odometer.
- b. Occasional improper alignment of the pinion bearings in the pinion bracket.
- c. Burrs.

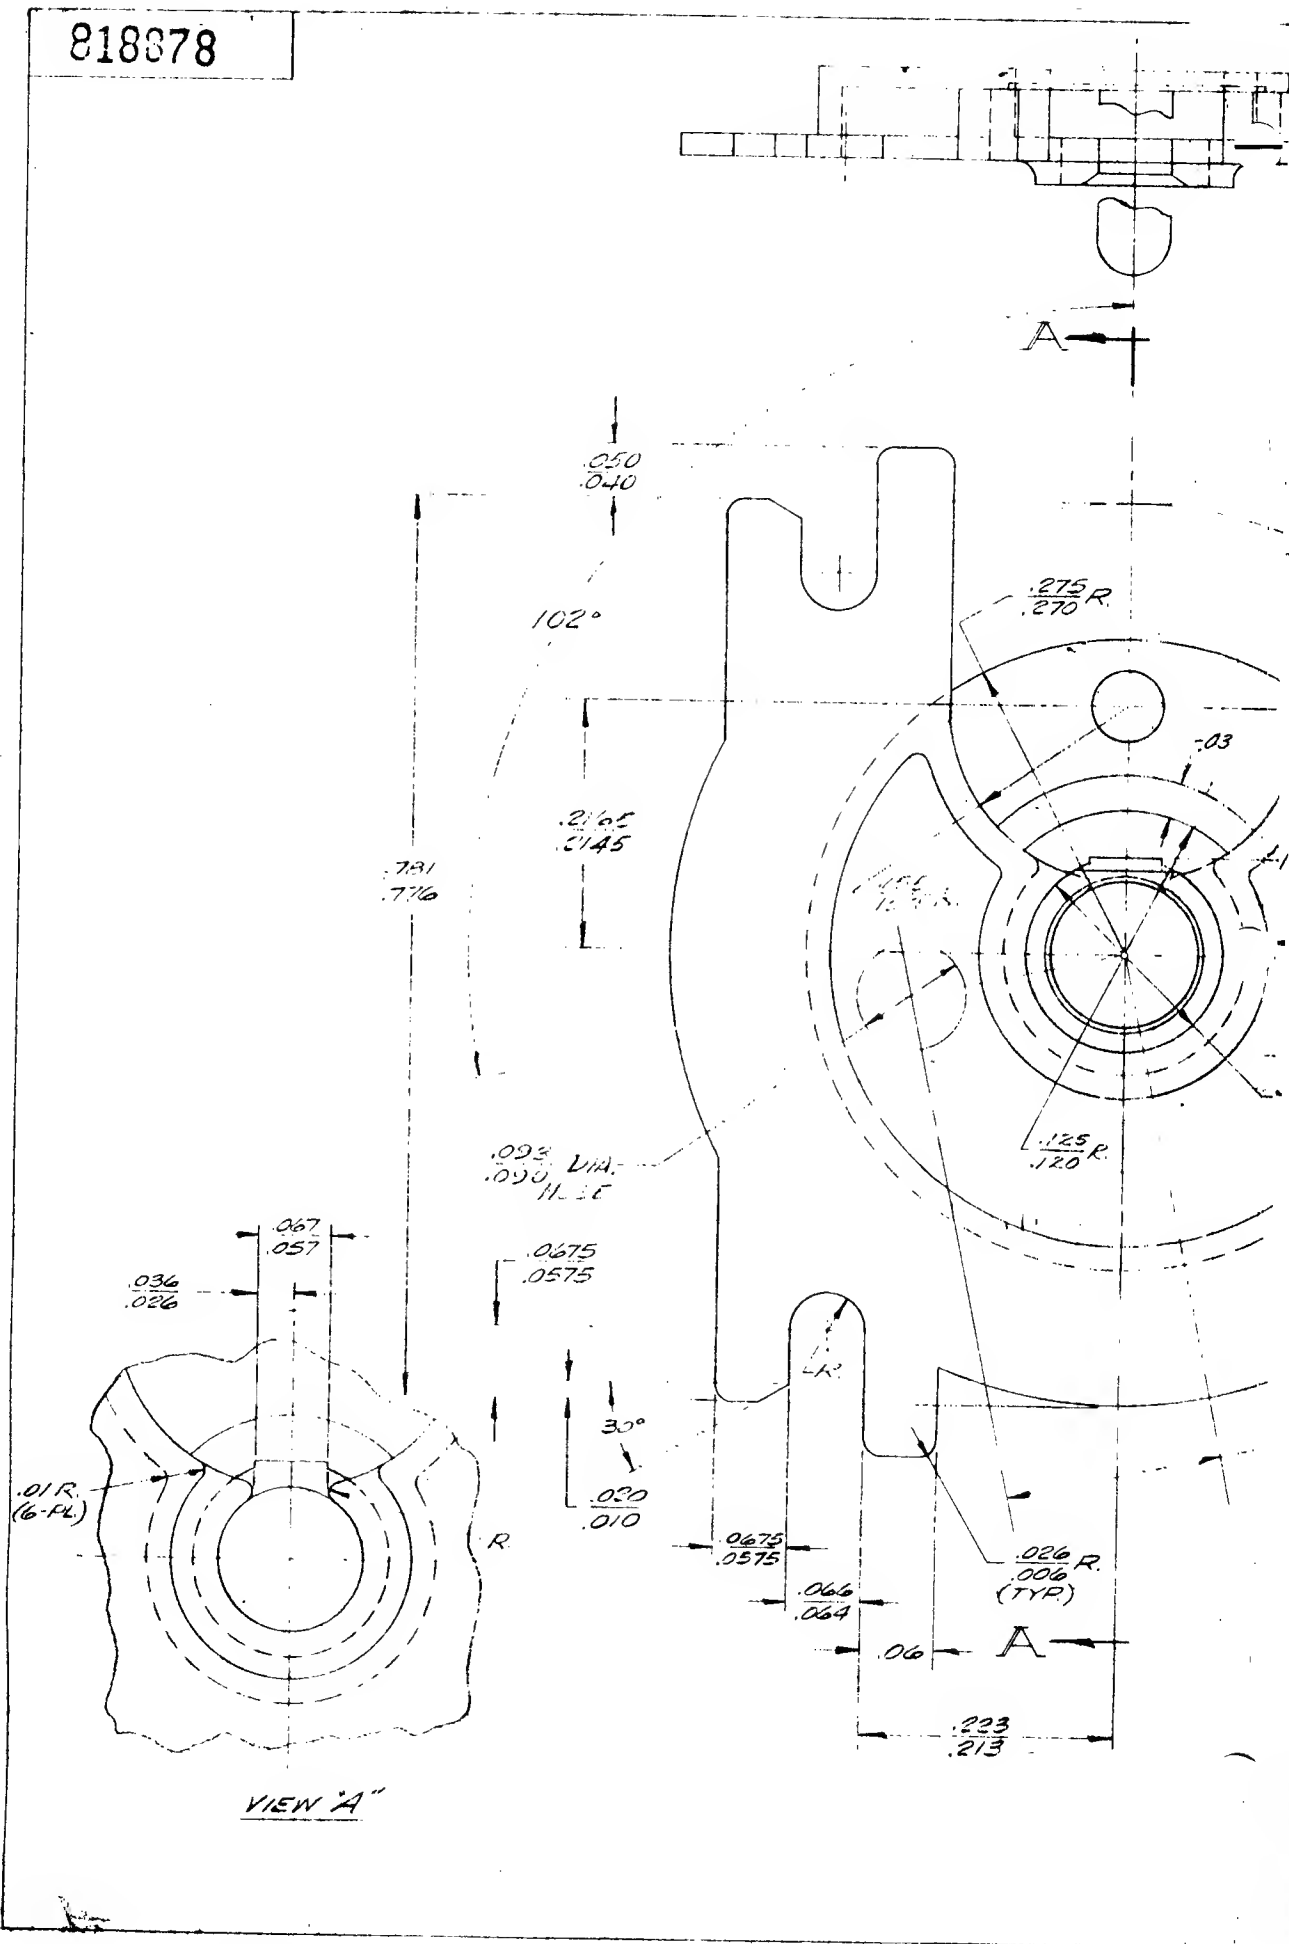
Exhibit B-1 ALL PLASTIC PINION BRACKET

all the parts were perfectly aligned during the welding assembly, plastic pinion bearings were easily sheared and partly damaged. This was producing excessive looseness of the pinion and hence causing it to lose contact with the internal teeth of the meshing dial wheels.

Mr. Powell knew then that he had to eliminate completely the welding operation. He decided to make a uniform, single piece part to replace the two brackets of the carrier unit. The functional requirements of the carrier were re-investigated and carefully scrutinized, and a new plastic pinion bracket and pinion were designed. Refer to Exhibit B-1 for the new pinion bracket, and Exhibit B-2 for the new plastic pinion, and Exhibit B-3 for pinion and bracket assembly. With this new design the vibration and the welding problems were completely solved, and the pinions were free of objectionable burrs. This design was immediately incorporated into the bicycle speedometer assembly. However, it soon became apparent that pinions could be dislocated from their proper positions by simply handling them during assembly operations. It was decided that this was undesirable for odometers that were sent to customers like Ford Motor Company for additional assembly into speedometers at their plant. This was attributed to the low rigidity and the excessive deflection of the short plastic shaft holding the pinion, and the poor locking characteristics of the new pinion in its seat.

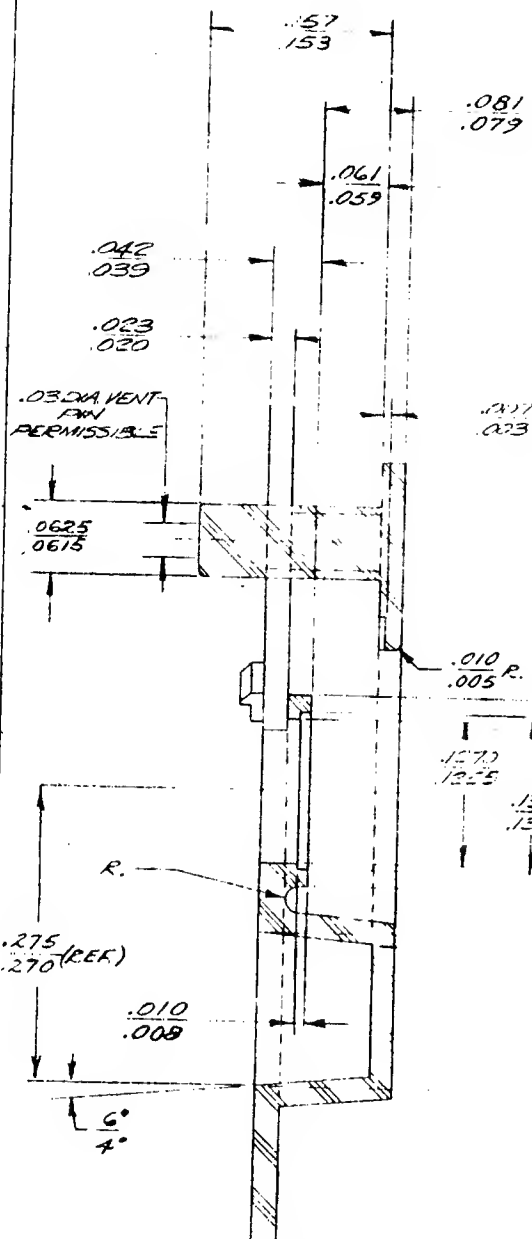
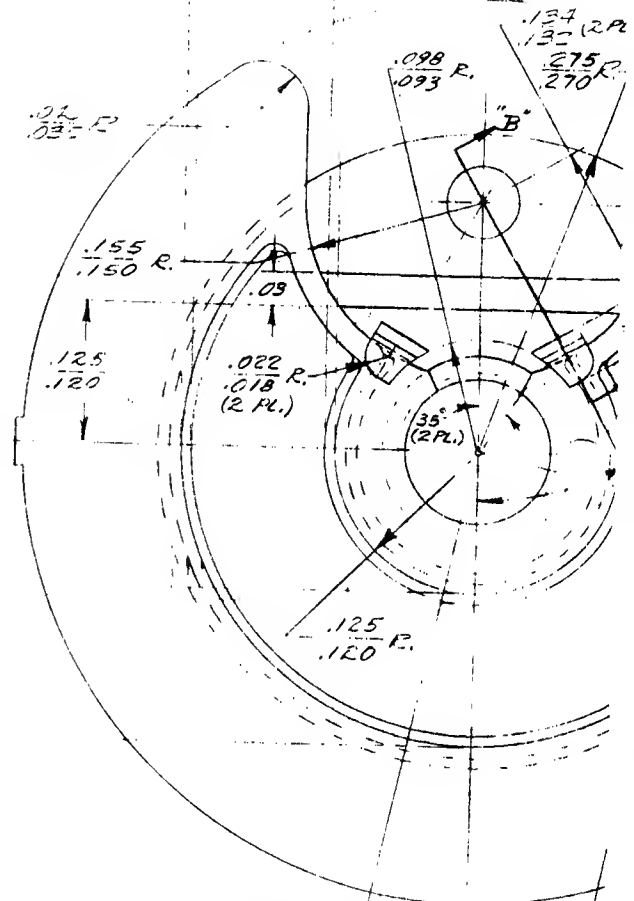
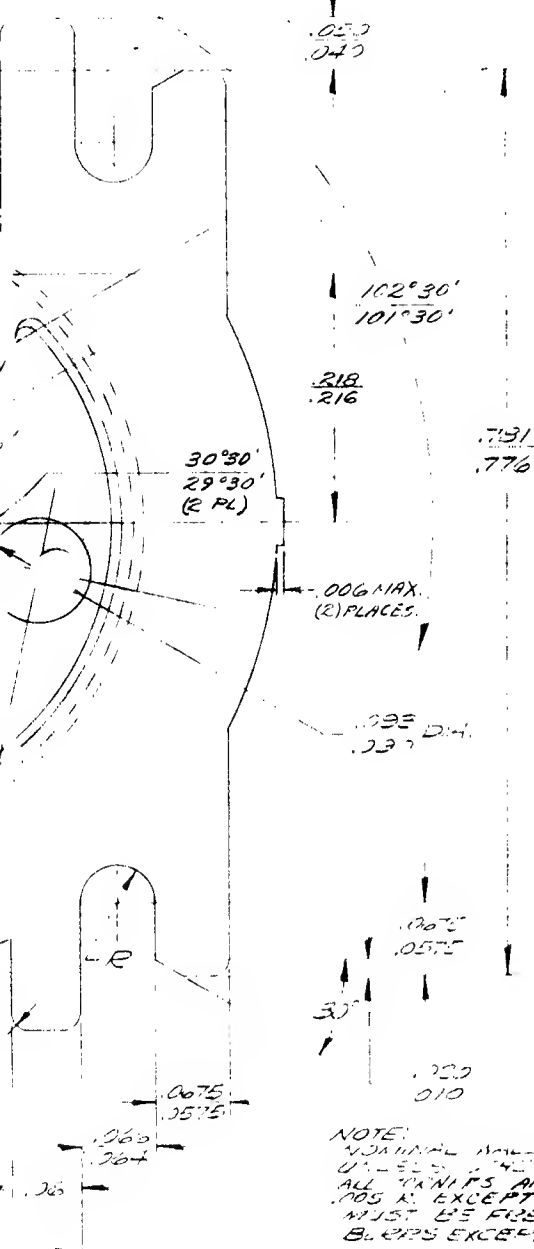
Exhibit B-4 FINAL DESIGN OF PLASTIC PINION BRACKET

During various tests it was noticed that if the raised portion of the plastic pinion bracket was near the side where the 2-tooth wheel was located, it was impossible to dislocate the pinion from its correct position. Hence, a final design which was now completely satisfactory had become a reality. This was obtained mainly by rotating the plastic carrier 180° around its vertical axis from its original position. A new plastic pinion which had better locking capabilities was incorporated with this design. Locking flanges in the pinion bracket were increased to secure

the pinion more rigidly in place. Exhibit B-4 is for the new pinion bracket, Exhibit B-5 is for the new pinion,^{*} and Exhibit B-6 is for the final pinion bracket assembly. Exhibit B-7 shows photographs of the pinion and bracket assembly through all the design stages and also the odometer plastic wheel which was unchanged.
